DEPARTMENT OF TRANSPORTATION

Quality Assurance and Source Inspection

Contract #: 04-0120F4Cty: SF/ALA Rte: 80 PM: 13.2/13.9File #: 69.15**SOURCE INSPECTION REPORT****Resident Engineer:** Pursell, Gary**Address:** 333 Burma Road**City:** Oakland, CA 94607**Report No:** SIR-000692**Date Inspected:** 26-Jun-2009**Project Name:** SAS Superstructure**OSM Arrival Time:** 0**Prime Contractor:** American Bridge/Fluor Enterprises, a JV**OSM Departure Time:** 12**Contractor:** Zhenhua Port Machinery Company, Ltd (ZPMC), Changxing Island **Location:** Changxing Dao, Shanghai

Other: Surface Preparation and Coatings Application**Bridge No:** 34-0006**Component:** OBG L2W, 1AAW, Misc. Metal, Tower L2S**Bid Item:** 77,78,79,80**Lot No:** B226**Summary of Items Observed:**

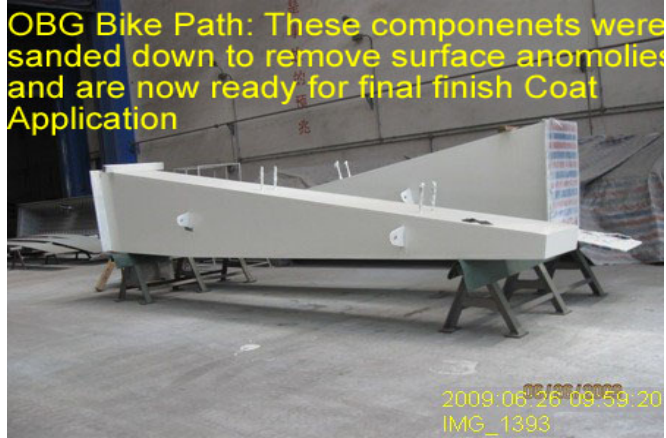
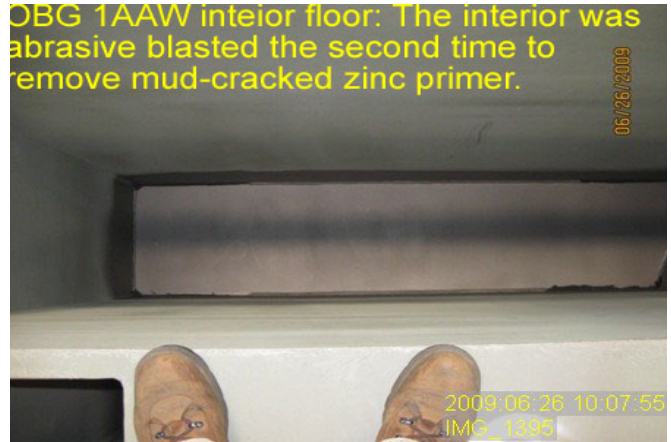
Fabrication on assembled components of the OBG's and Towers are not complete. Outstanding weld repairs have not been performed. Coating damage requiring re-blast is expected.
